Signals From The Point

Official Newsletter of the Caribbean Contesting Consortium
Editor: W0CG

Volume 19, Number 11

November 15, 2019

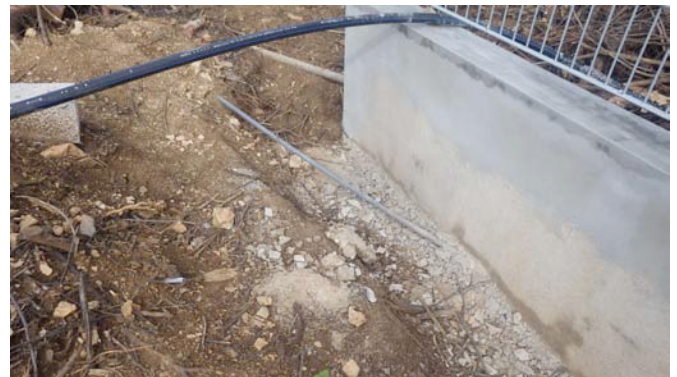
I spent a couple of hours moving construction debris and brush across the street and finally found our Beverage feedline. I buried that in 2003 and had not seen it since, but the construction had unearthed it. Amazingly it all looked intact, and a huge thanks to our neighbor Dirk who saw to it that they dug very carefully. In fact it is better than that because he found our conduit, handled it with great care, and even poured the foundation of the new security gate around our cable, as seen below. The photo shows the grey conduit containing the Europe Beverage feedline, routed through the footer for the security gate. Thanks Dirk

So the visual checks of the feedline all looked good. After closer examination of the road junction box on my hands and knees with a flashlight, I realized that the coax connector was goosed up with moist conductive corrosion, surely from the flooding deluge that happened about three weeks ago. A river of water had flowed over and around this box during that storm. My careful waterproofing from years ago had cracked slightly and let in some water. After cleaning that up the Beverage suddenly worked again, and Uli used it to good effect working Europeans in the WAG contest on 40.

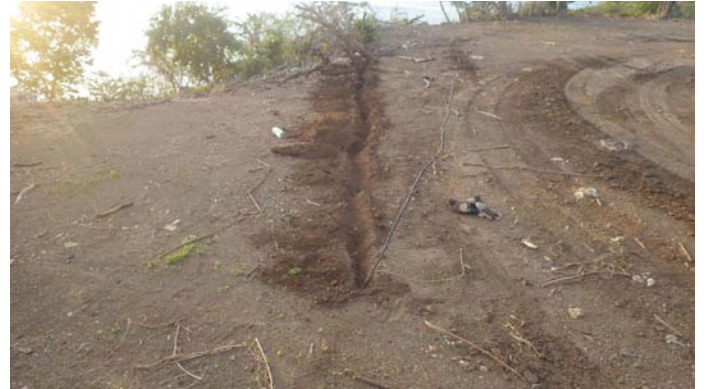
It's hard to get very deep because the dirt is so shallow here, but this is tough cable (Davis RG-8 BuryFlex), and I'll encase parts of it in tough flex conduit and then cover and tamp the ditch.

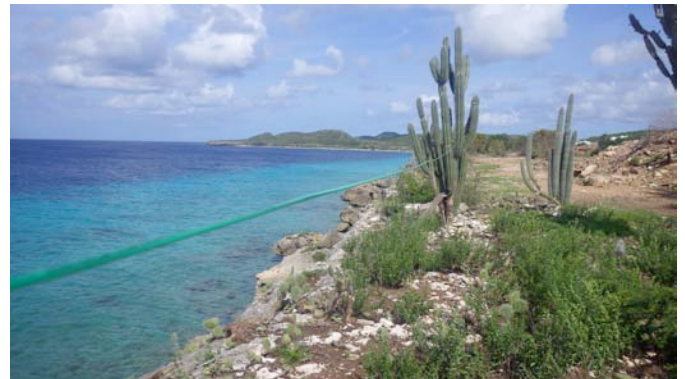
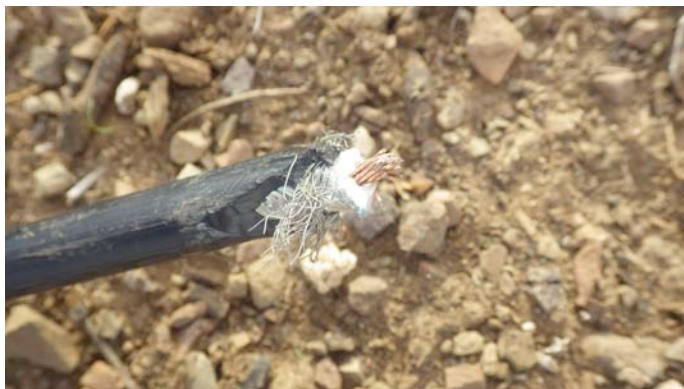
Our buried feedline to that US/JA Beverage was lying partly exposed on the ground after the attack of the bulldozer. I pulled the rest of it out and this ragged end is all that was left of our nice 840 foot receiving antenna, the transformer and termination system, and the radials at both ends. The photo shows the inglorious remains of our beautiful US/JA Beverage after the bulldozer got it.

From that tree we strung out a temporary 500 foot Beverage along the route of the old one. There are just enough trees remaining to provide reasonable support for the wire. The photo shows the green Beverage antenna looking toward the States.

This antenna performed very well in CQWW SSB, but we removed it the day afterward because this wire is much too visible and thus much too tempting to vandals and scrap metal collectors. Thanks K8PGJ and K8IV for help in assembling and installing this antenna. We used a new KD9SV 9:1 transformer at the feedpoint and a new 470 ohm termination, both from DX Engineering.

I cleaned up the end of the coax (seen above) and Uli and I ran some checks to verify that the cable was still good from the shack. There was enough length left to get to a small and sturdy tree along the cliff edge, so I set about digging a trench to get it as deep as possible in the hope that it would survive for the contest. Here's the ditch at about half depth. I finished it the next day.

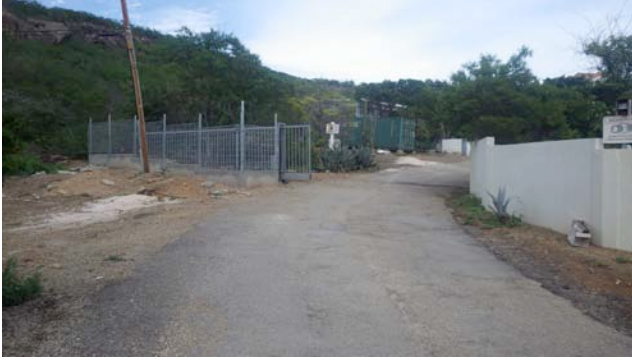
Here's the new security gate in place. The hard work is done, but the toothed bar and drive motor and controls still need to be installed. There will be multiple ways to activate the gate, including keypad codes, remote transmitters, and something like EZPass for the garbage truck. We owe a huge thanks to our neighbor Dirk van Daam, who prevented the contractors from digging up our buried transmission lines to the Ridge.

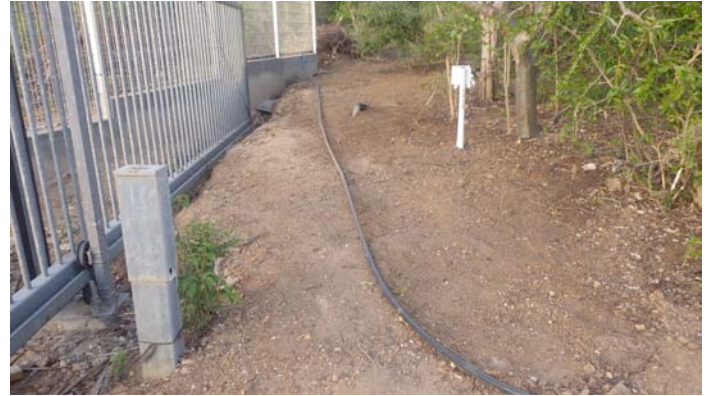
Following is a photo of the white aluminum post set in concrete with the RX cable junction box on top. The cable feed conduit behind the white post is 1 inch rigid plastic conduit. The four RX lines from the shack go up to the box from underground in the 1 inch. Each feedline to the RX antennas on the Ridge will connect into this box via flex conduit. It's white because that's the color of epoxy paint that I happened to have on hand. It has two coats for lifetime protection.

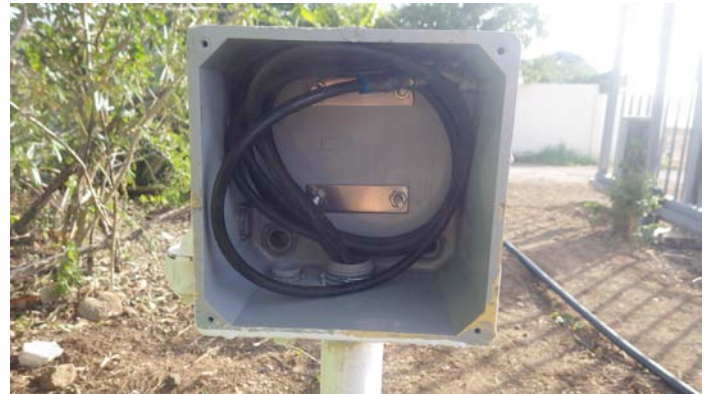
Here below are the four RG-6 runs from the shack, terminated inside the white box across the road.

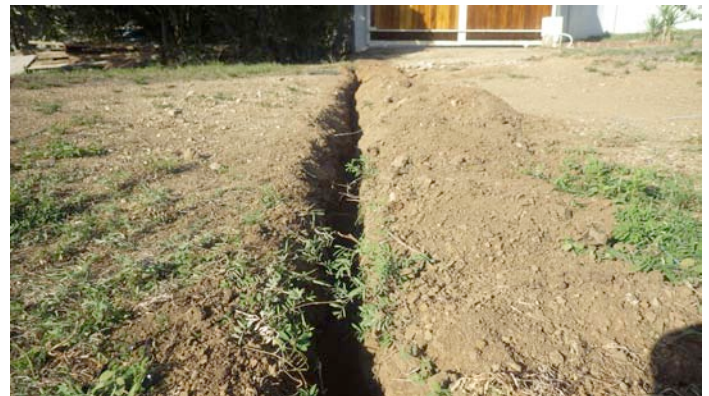
The following photo shows part of the route the RX cables take from the shack to the box across the road. This trench is about 10 inches deep and was very tough digging because this area has been saturated with drainage water and driven over by vehicles for years. The underground portion of the route is comprised of two runs of 1 inch watertight flex conduit, 84 feet in length each, and each containing two RG-6 cables.

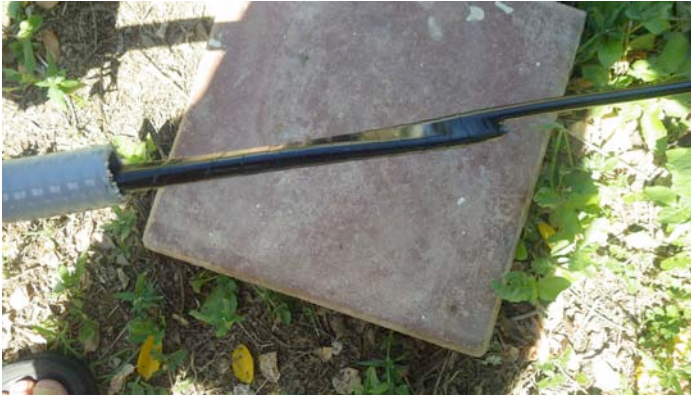
It took an entire day to make up the cable runs from the shack to the road. The first step was to persuade 84 feet of RG-6 through the conduit using liberal amounts of cooking oil. Following that, the single RG-6 was then used to pull two cables through, as seen below.

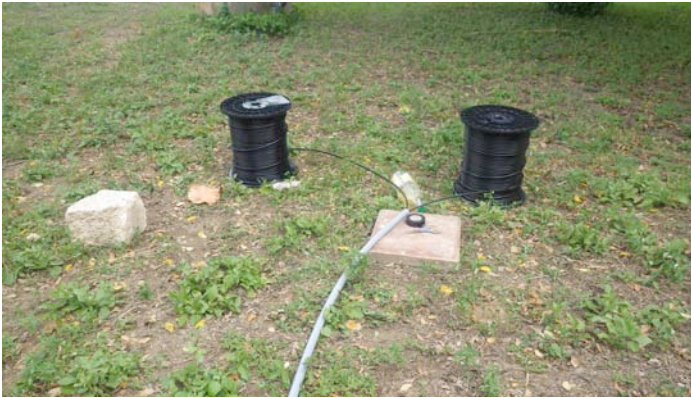
Next photo shows the arrangement for pulling two runs into one conduit. Each of the four pieces of coax is 410 feet long, so handling four of these was quite an operation working alone.

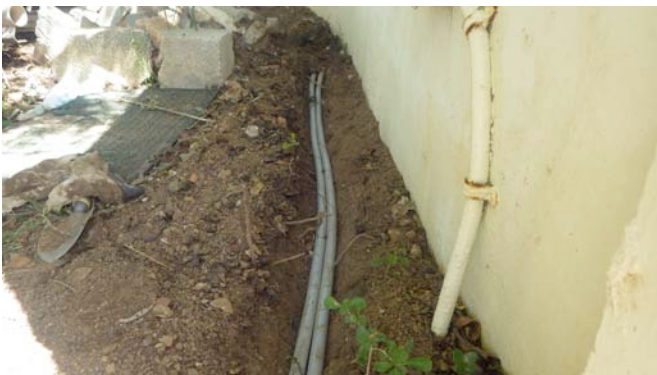
Here (below) are the two conduits in their ditch along the wall behind the pile of old tower parts. Most of this had to be done on hands and knees because of the mess of old tower parts back there and the tight quarters and thick vegetation.

The conduits are in, the ditch covered, and the four cables are in the shack awaiting termination and connection.

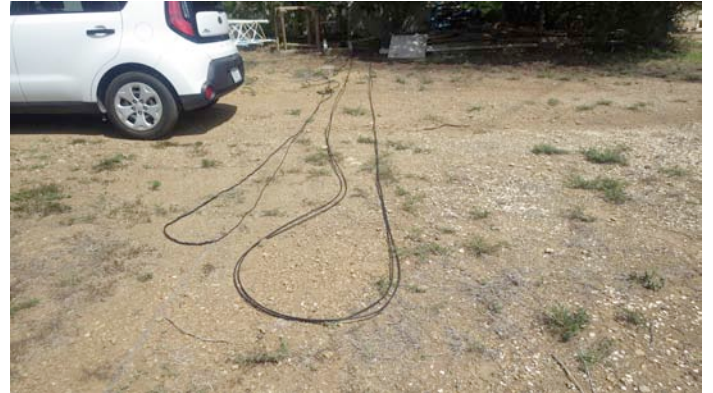
off. The pull rope has been waiting patiently in the conduit all these years, and it was relatively easy to pull in the four RG-6 runs, two at a time, under the road. Here's the arrangement for the pull as seen in the backyard.

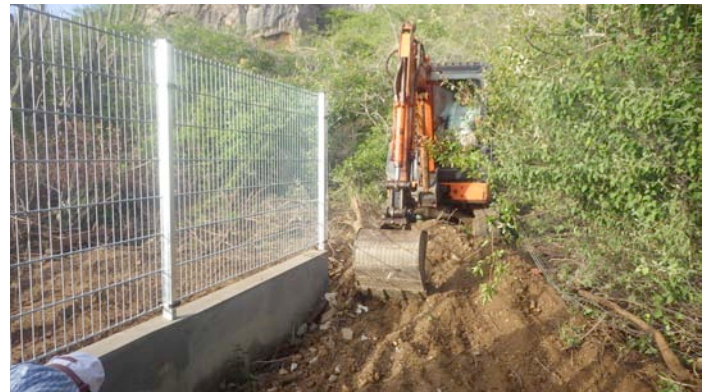
We almost didn't make it. Prior to installing the box the area across the road was a mess of piles of brush and dirt and concrete chunks from the construction of the gate. Our cables for the Ridge were somewhere in that mess. I knew that an excavator would be showing up some day to clean all of that, and when I heard him start I went running to protect our cables. The guy did manage to hook and pull out the Heliacx to the Ridge with the bucket of the backhoe, but my screams stopped him just in time and the cable did not get broken. I spent the next two days hand-clearing and grading the rest of that area, and then re-burying our cables for protection. Here's the Backhoe from Hell as he came close to trashing all of our buried cables.

It was a very close call, but the digging is now complete over there. Our cables (and water line and phone connection) are safe, and the area will soon be covered with geotextile and then a layer of decorative rock. I can breathe again.

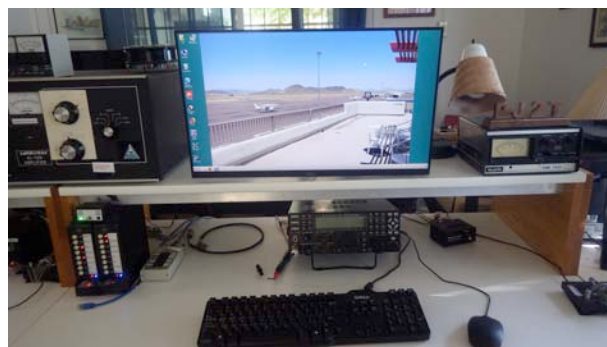
I arrived in mid-October to find that the top third of the Station 3 monitor image had pretty much disappeared. We used a backup 20 inch monitor for CQWW SSB, but the CCC leadership instructed me to get a new, bigger monitor before the code contest. Here's the new Dell 24 inch monitor that I installed on November 10.

This was \$285 including tax at a local store. Good use of some of your dues money. The 40 meter operator will be happy in the CW contest.

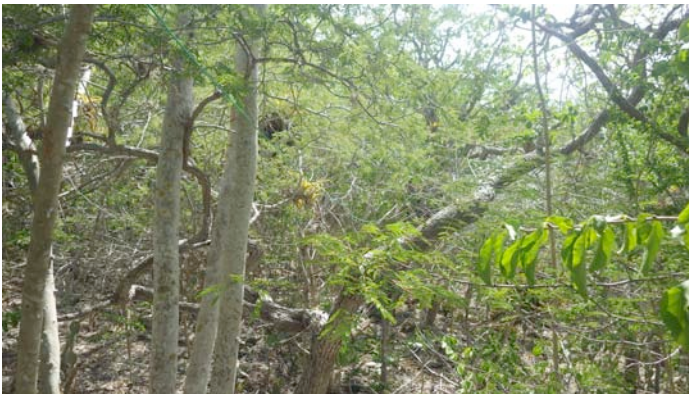
The bulldozers set us back for awhile, but now we have a better than ever permanent new US/JA Beverage. As planned, I installed an 880 foot run of wire very high up on the Ridge in an area where there will never be any development. It took seven long work sessions over six days up on the Ridge, but now the feed transformer, ground radials, and N7IR choke are installed at the feedpoint, and the resistive termination and ground are in place at the far end. If you look carefully you can see the green #14 solid copper wire draped through the very thick vegetation. This antenna is spaced a healthy distance away from the Ridge transmit antennas.

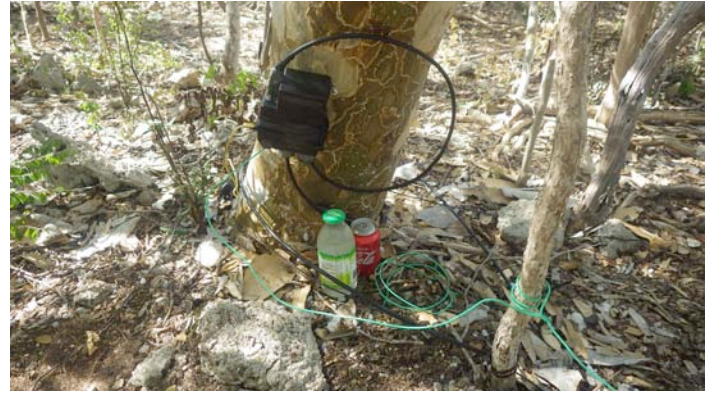
Following is the feedpoint for the US/JA Beverage, complete with beverages on hand for the next visitors. The N7IR choke and transformer are attached together

and the whole assembly is screwed into a stout hardwood tree. The antenna wire is green.

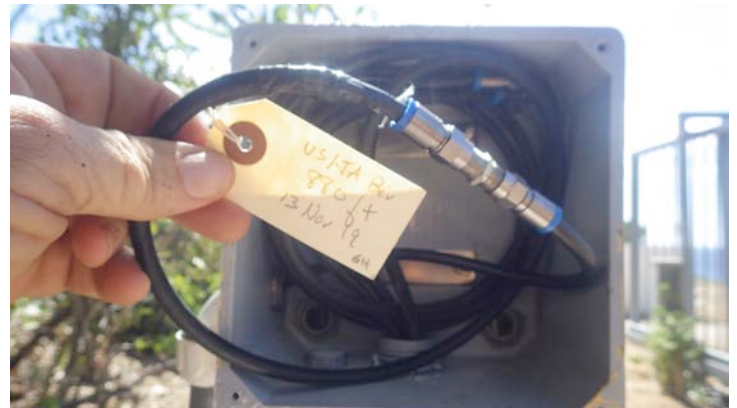
Below is the final connection in the road junction box. It's gratifying to have this done after so many months of planning, acquisition of materials, and the hassle of shipping them here. Feedline length is 765 feet from the antenna to the road box plus 410 feet from the road box to the shack, 1175 feet of RG-6 in total. This project consumed hundreds of feet of wire, coax, and flex conduit, but it's done now and will be safe from bulldozer attacks.

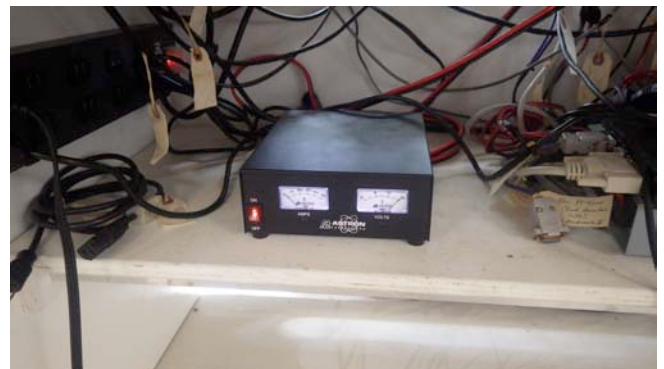
Stations 1 and 3 now have new power supplies, 50 and 30 amps respectively. Thanks N7IR for making this happen. In connection with swapping the supplies, we installed direct DC runs to the K3s. Here's the small, lost-looking new switcher at Station 1.

Now all four stations have switchers, and the old Astron transformer supplies are being retained on site as backups.

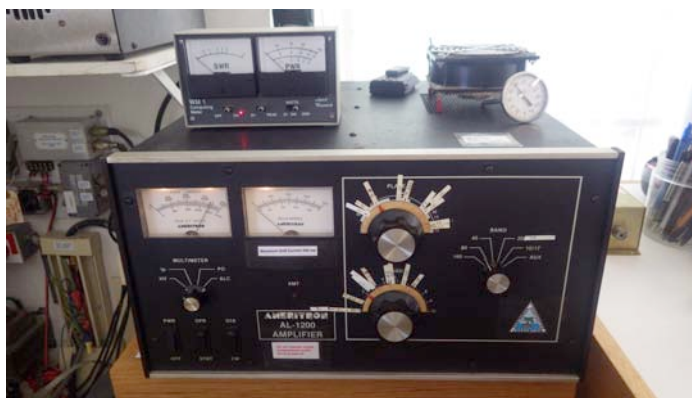
And now it's in service at PJ2T...! It's performing perfectly after the ocean trip, and we are much indebted to Art Brown, W3KHZ/VY2MM (SK) and Marty. We'll use it fondly in Art's memory.
